Competitiveness Operational Programme (COP)
Extreme Light Infrastructure - Nuclear Physics
(ELI-NP) – Phase II

The degradation level of the optical components inside the pumping lasers of HPLS

Young Researchers and Engineers Day
at ELI-NP, Măgurele, Romania

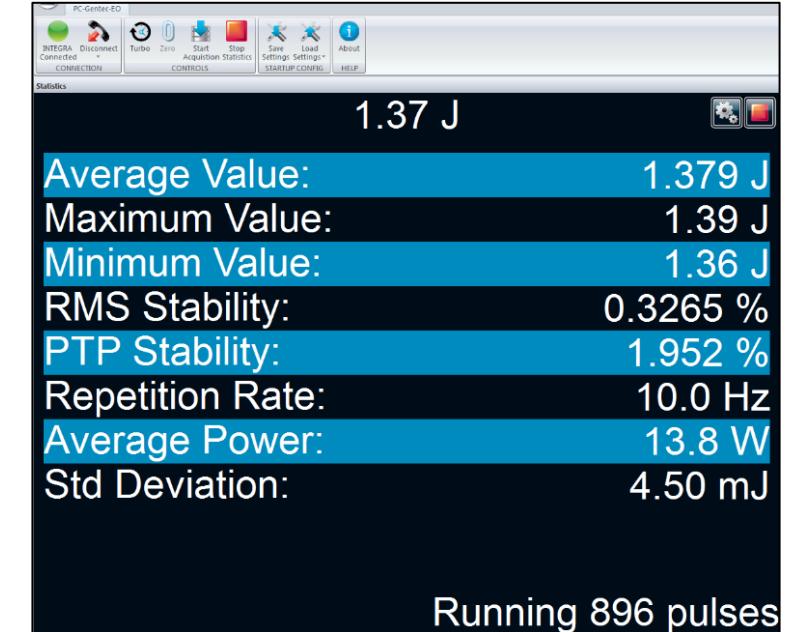
Fig. 4. Gentec software

In Gentec software:
→ $\lambda = 532$ nm
→ multiplier = 1.7
→ running pulses > 500

Energy → 1.37 J
RMS → 0.32 %
