# Contamination reduction in vacuum systems using Silica gel

Eng. Antonia Toma

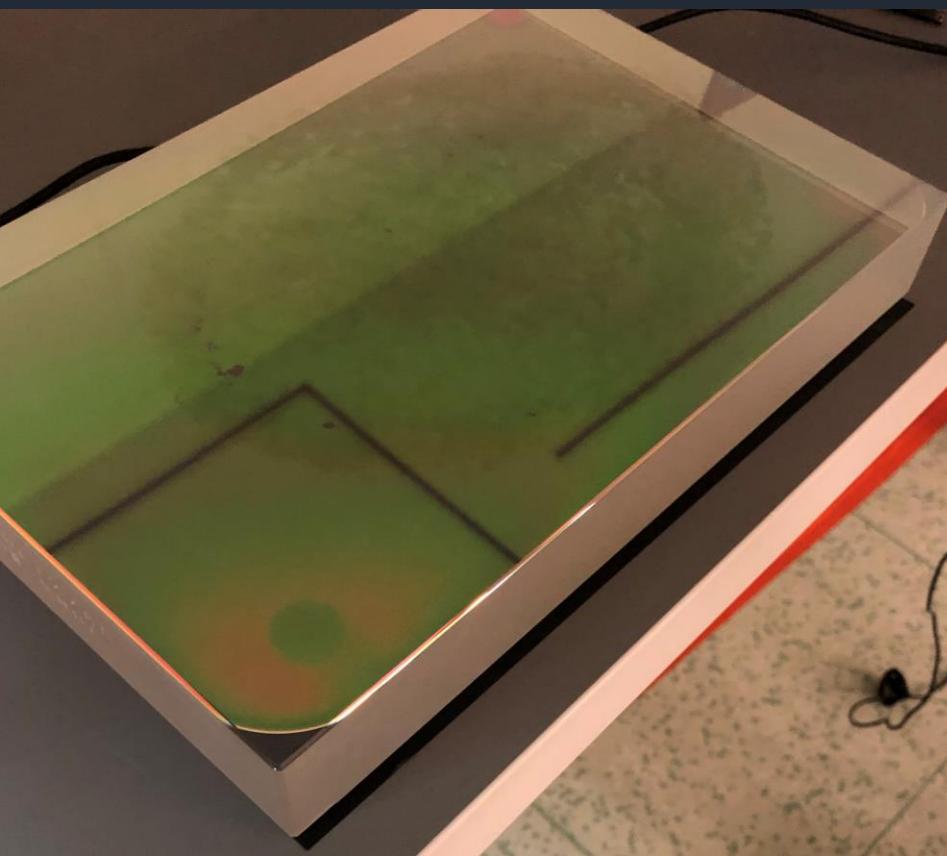
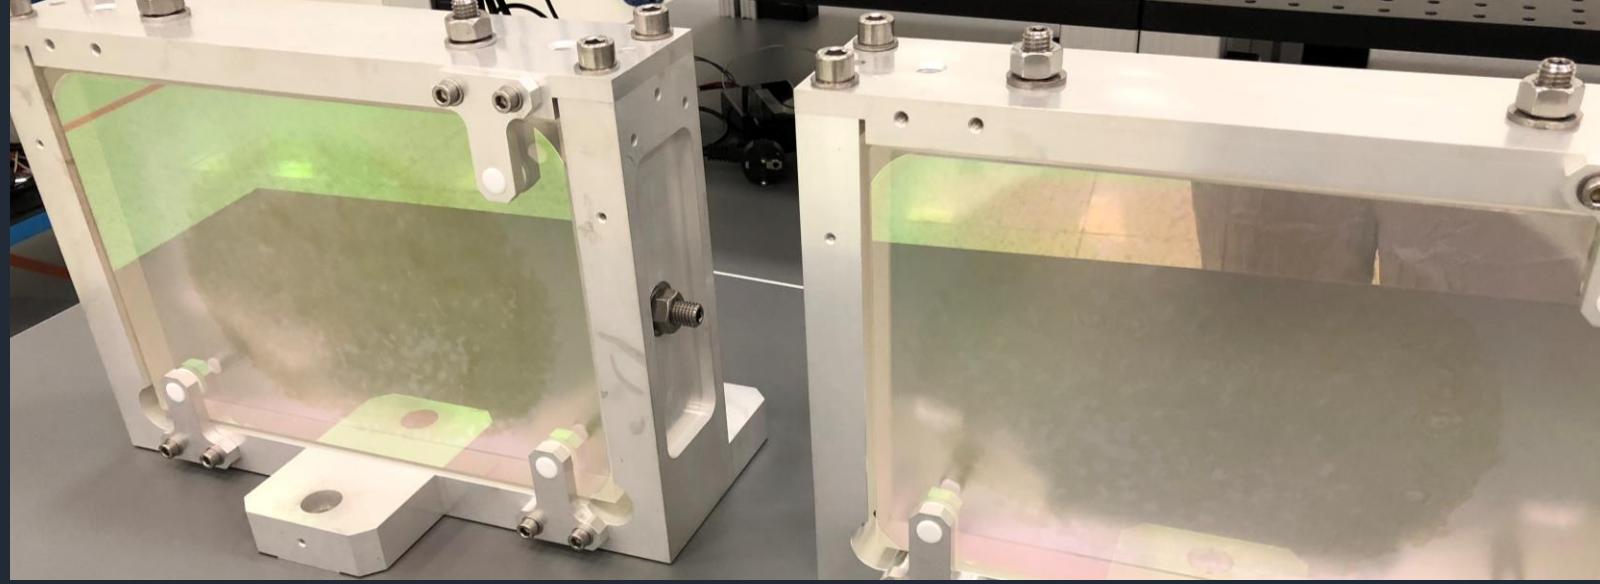
- We discovered signs of contamination of dielectric mirrors used in the vacuum chambers on 1 PW line after  $\sim 1000$  shots (December 2021).
- **Critical problem** from the point of stable operation of the laser system.

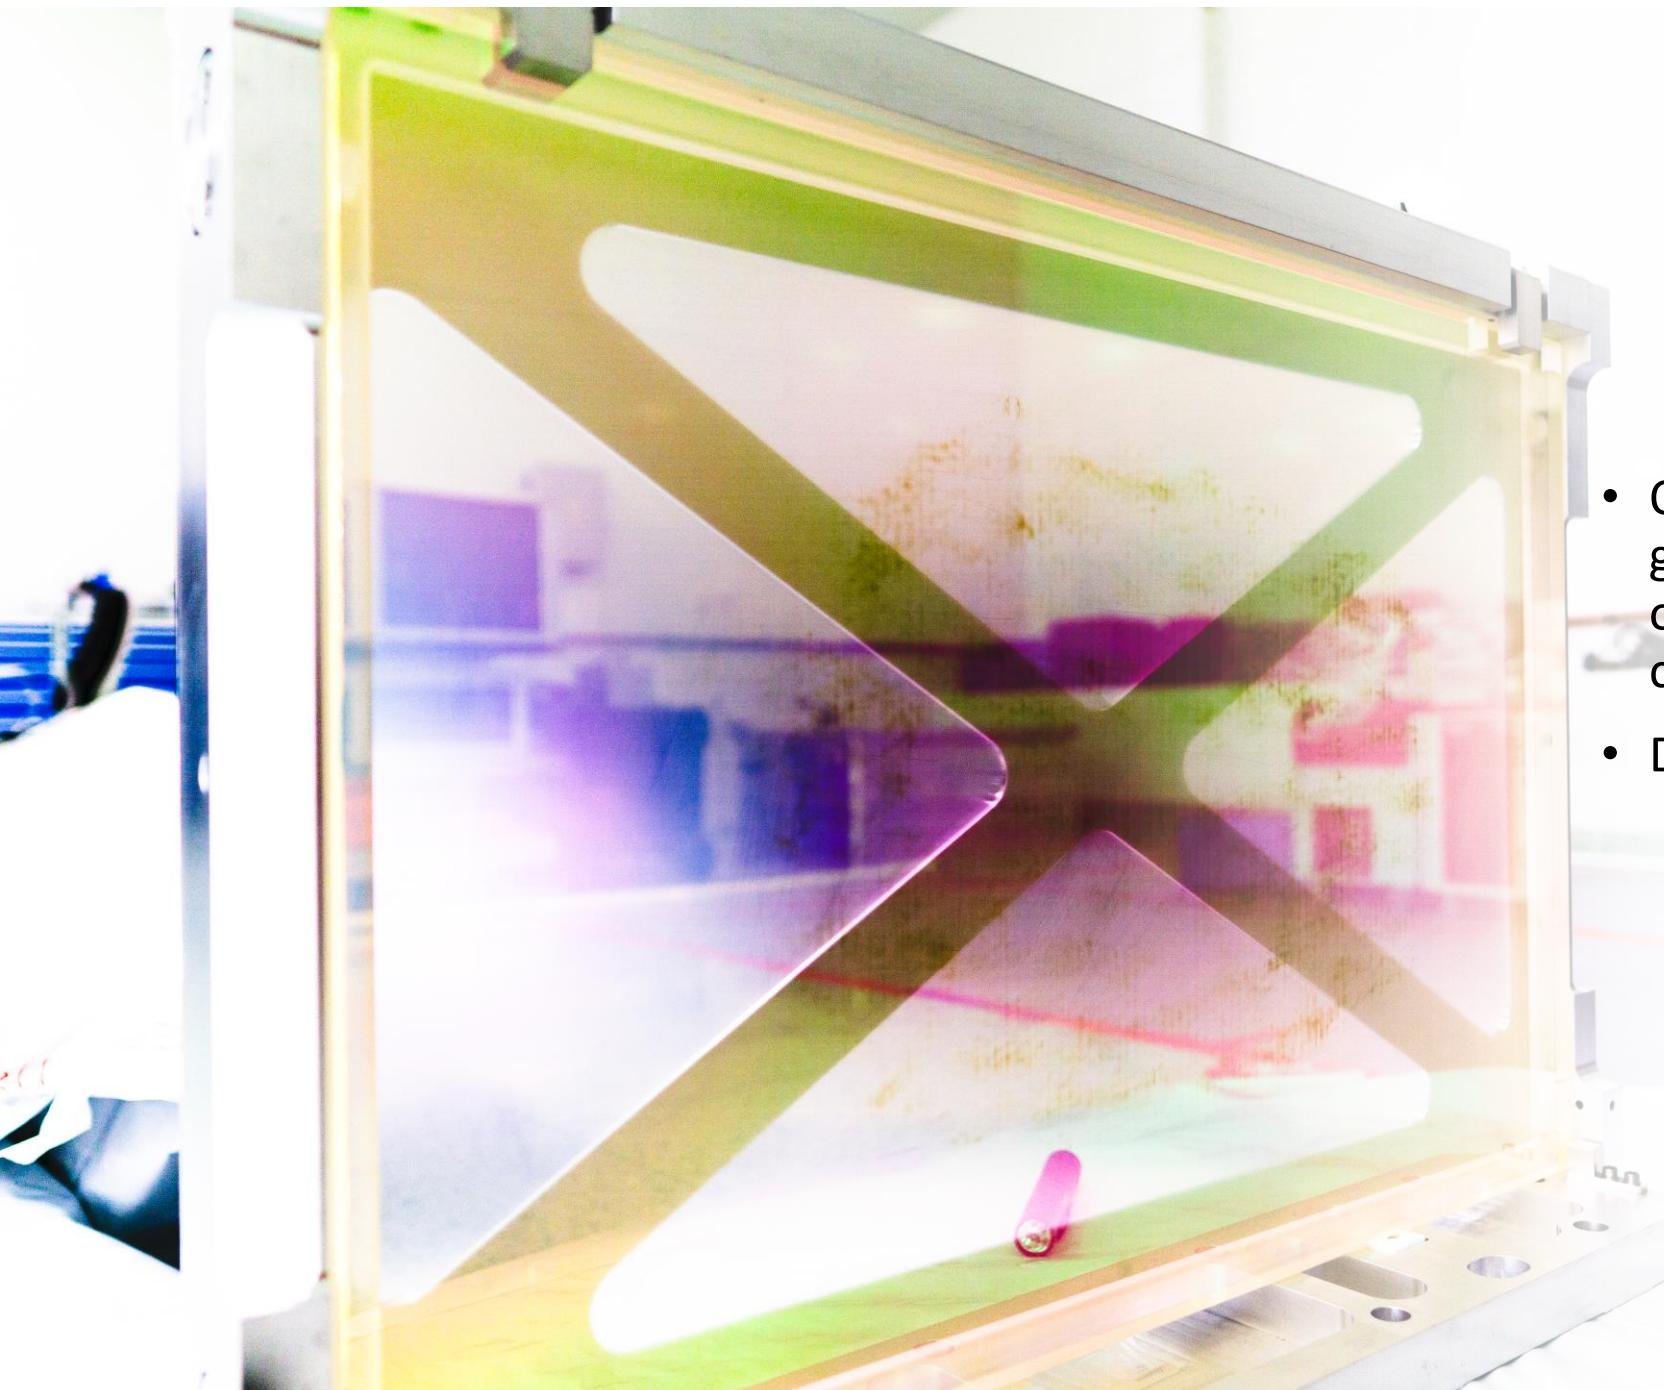
- On 10 PW line ~ 800 shots generated the carbonization of one of the large mirrors from the compressor.
- Date: October 2023

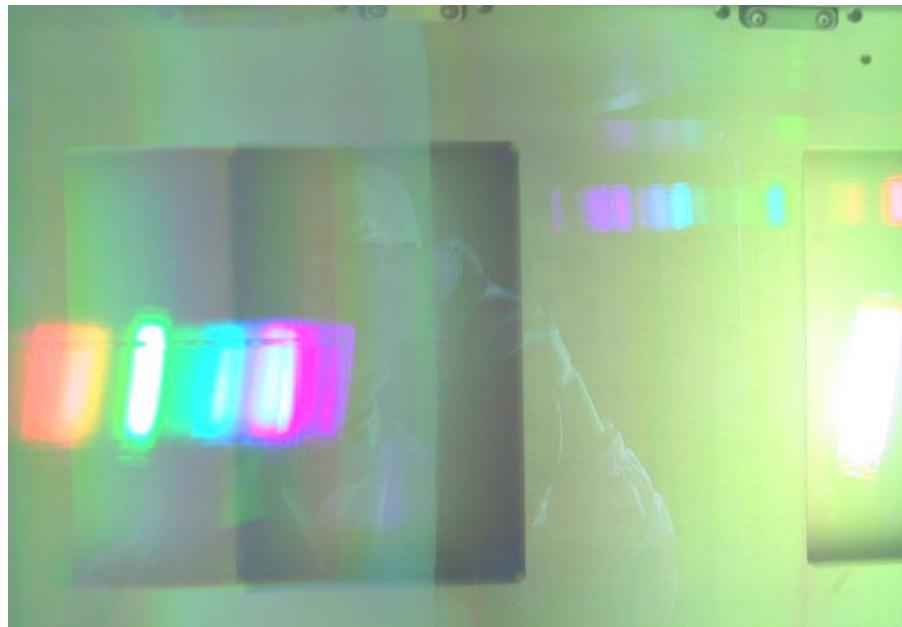
Fogged

- Contamination problem in vacuum chambers was previously observed in ILE Osaka. Fogging was noticed 3 days after optics was put from vacuum to air and **Damage threshold dropped  $\frac{1}{2} \sim \frac{1}{3}$**  in ns region.

Contaminated grating

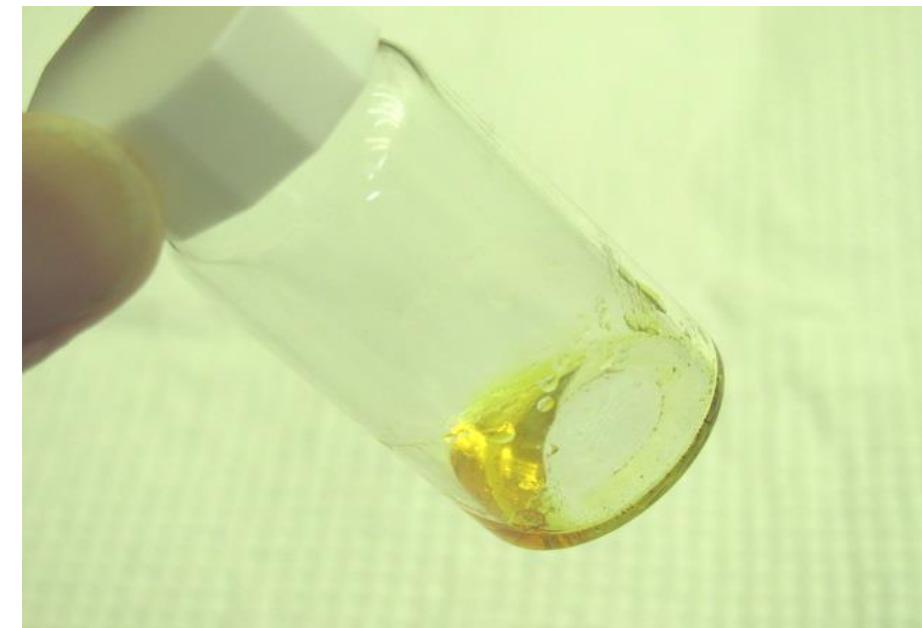
Rinsed

Accumulated oil from grating surface

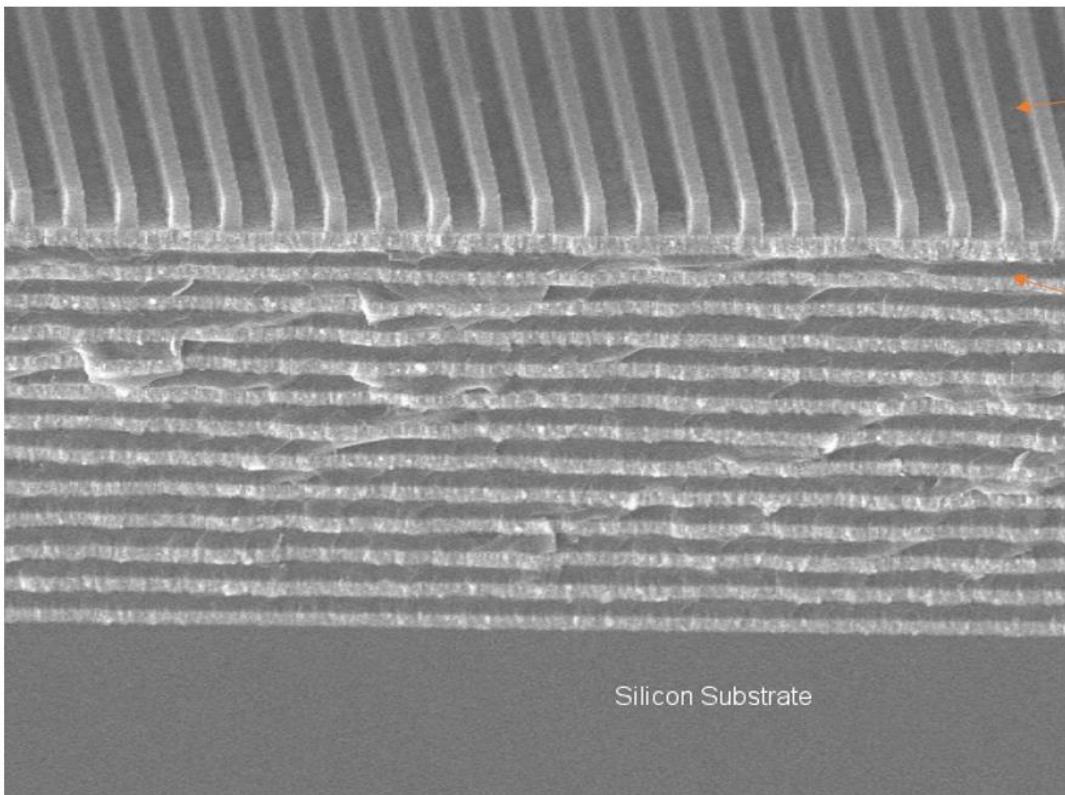
## Structure of coated layers

- The mirrors we use have multi-layer dielectric coatings.
- Coating layers have pillar structures, and they are well known to absorb the humidity, and, in the absence of humidity, they absorb the organic vapours **from the vacuum**.

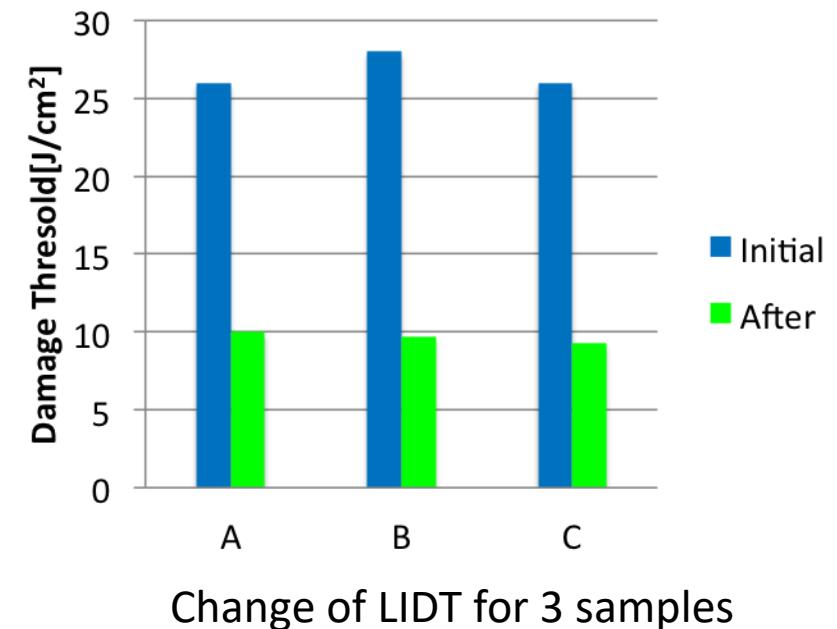
- Contamination induces:
  - 1) The change of reflective indexes of coated materials
  - 2) The dropping of damage threshold in the ns regime
  - 3) The carbonization will finally induce laser damage to the coating.

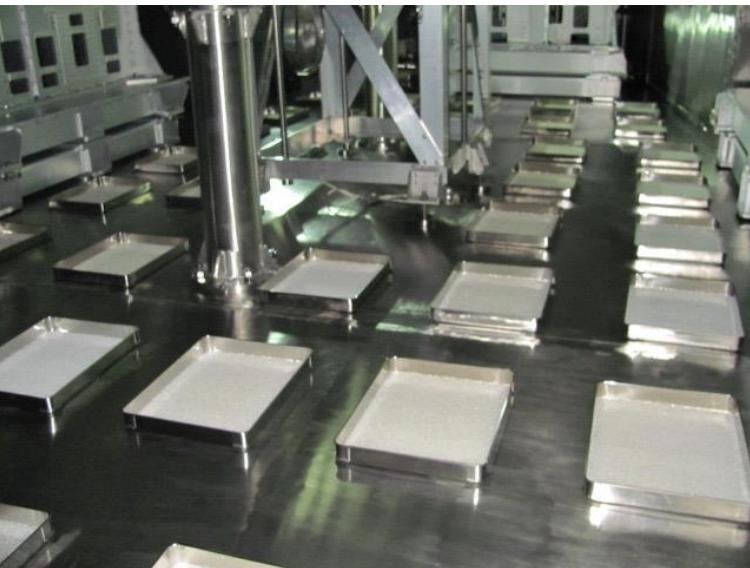
ILE-Osaka without mesh in 2013  
(particle contamination was observed  
due to emissions of Si gel itself)

- ILE Osaka used a large amount of silica gel to absorb the contaminants from the vacuum chamber. This method was transferred to ICR Kyoto (Japan) and Sandia Laboratory (USA).

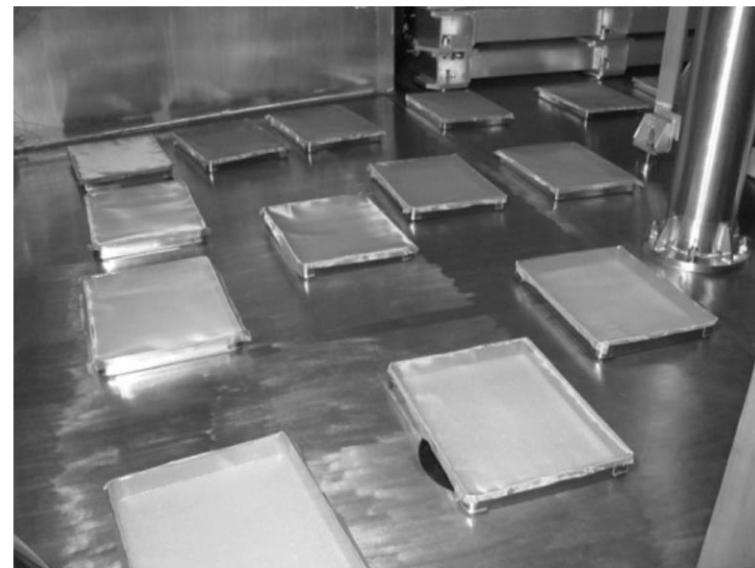
ILE-Osaka with mesh in 2014  
(particle contamination was removed)

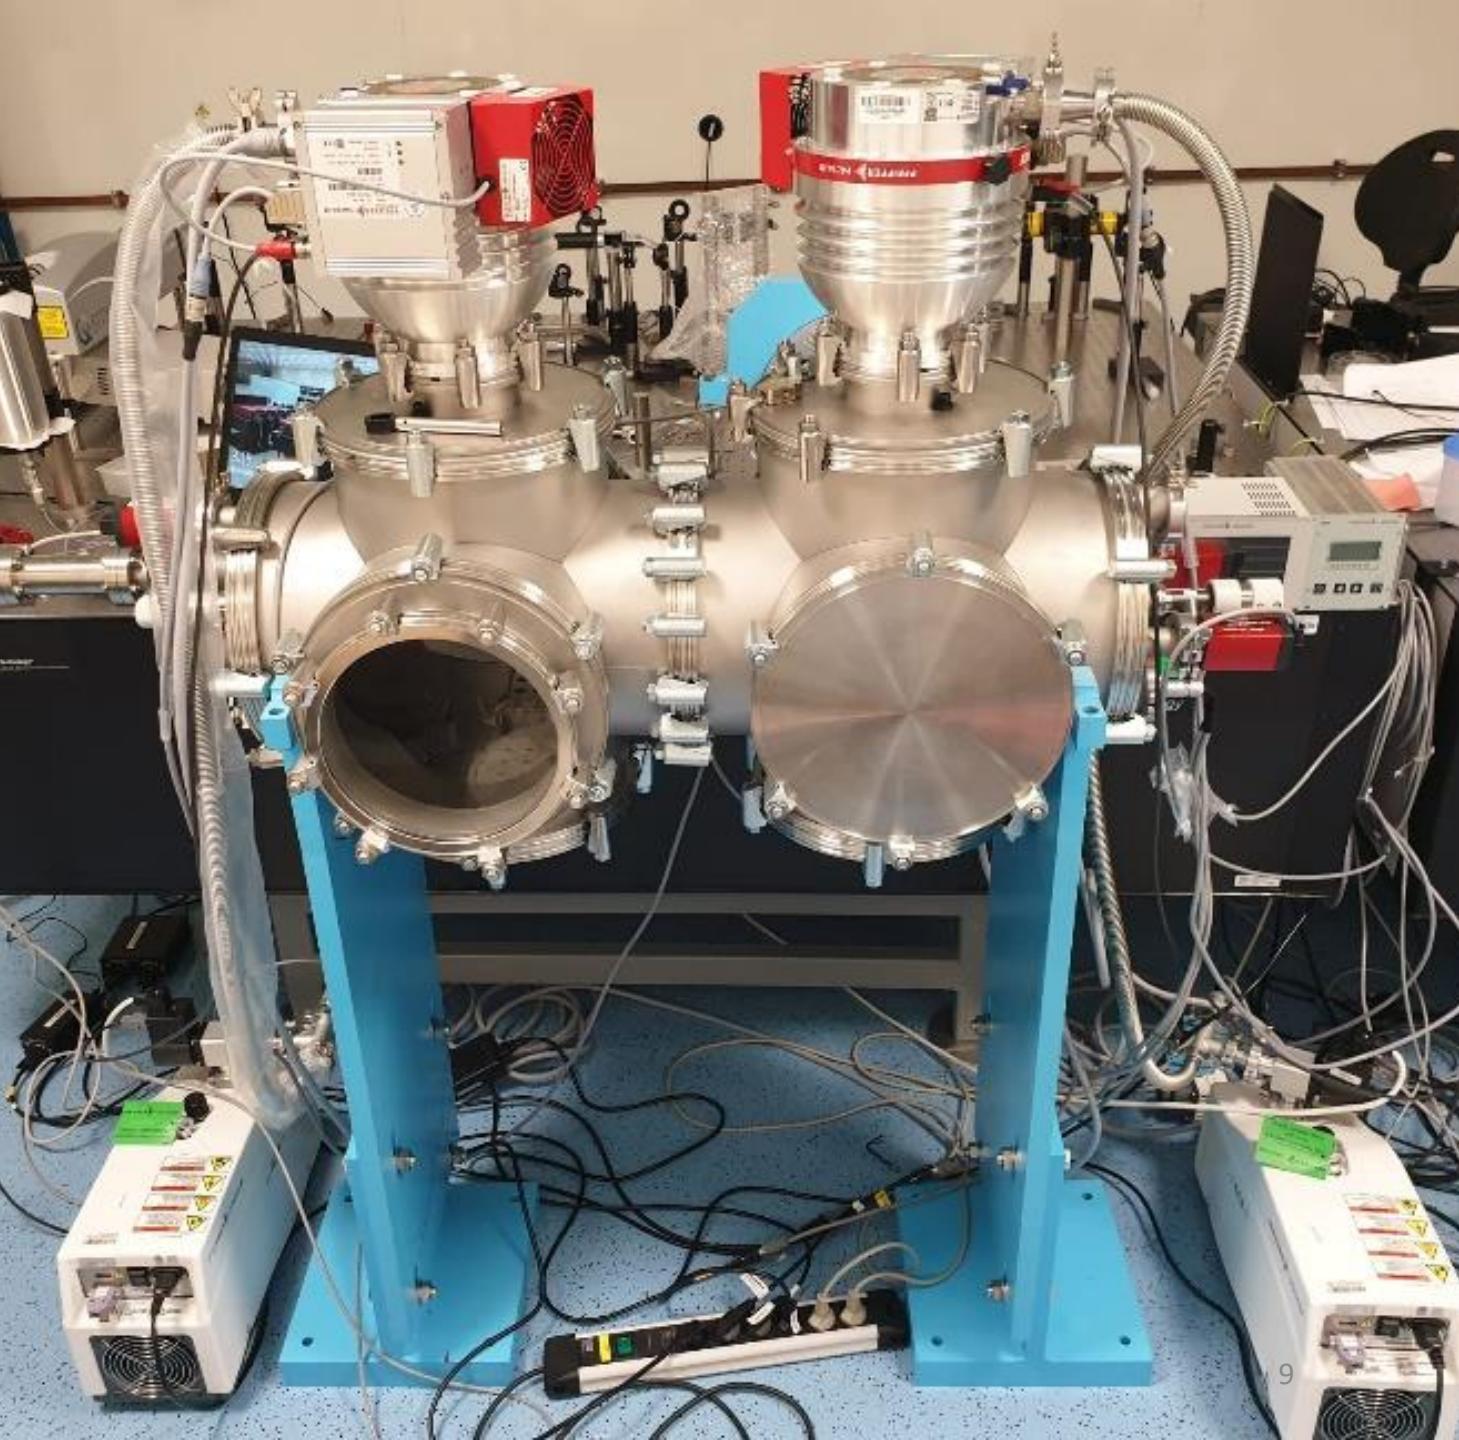
We need to make sure the particle contamination caused by the silica gel is minimal. To check this, we need to put some control samples in vacuum and then inspect them to see the default contamination induced by the vacuum chamber itself.

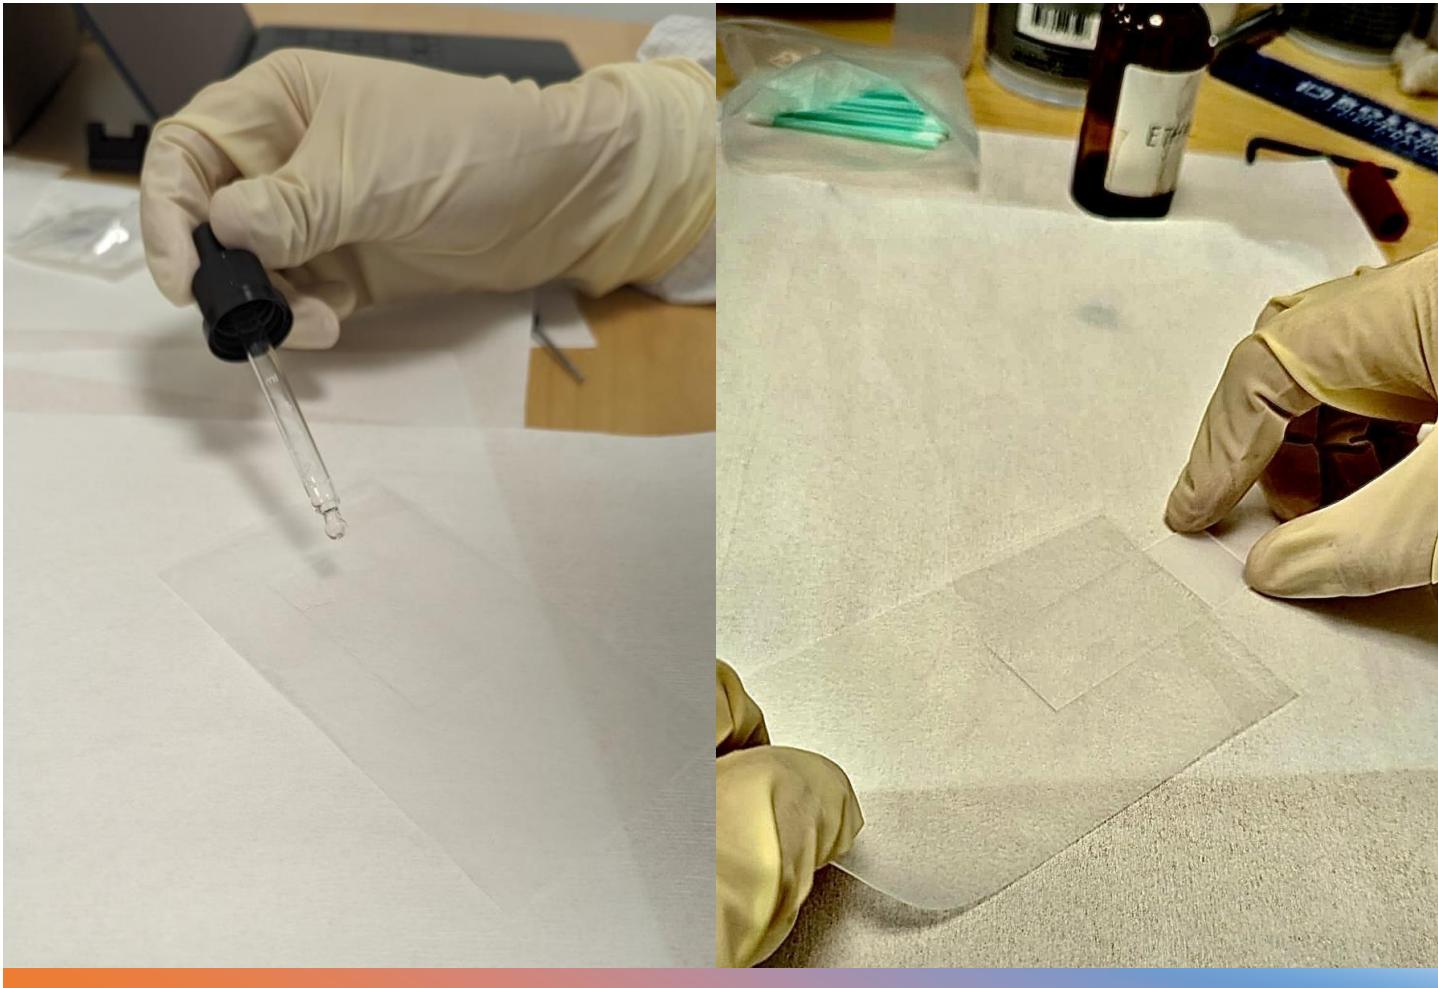
- First step we took was cleaning the glass plates used for the vacuum particle control sample using the drag wiping technique.

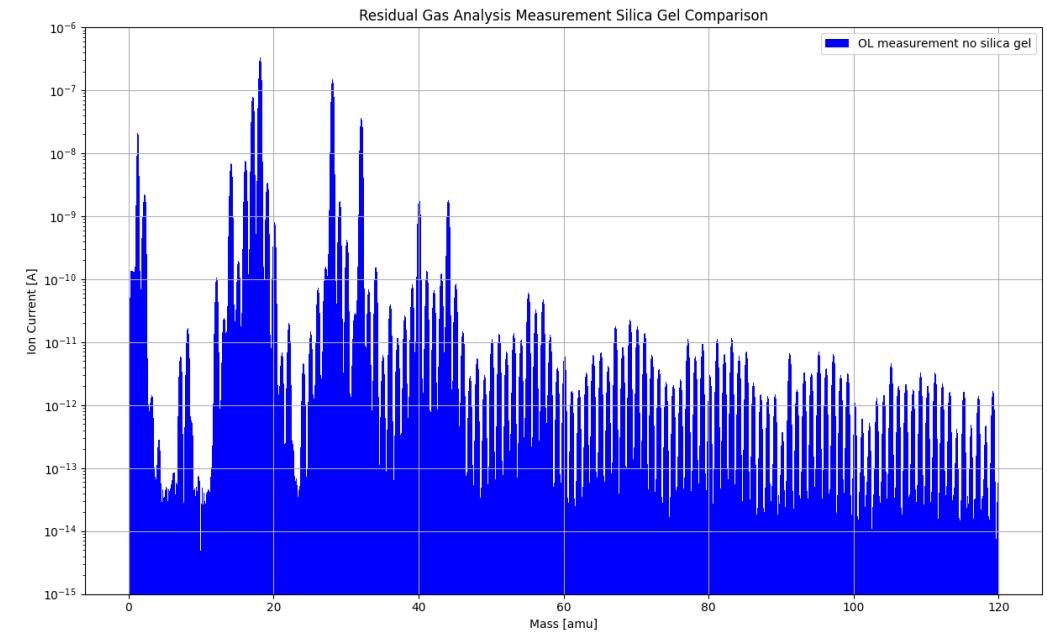
RGA data without silica gel

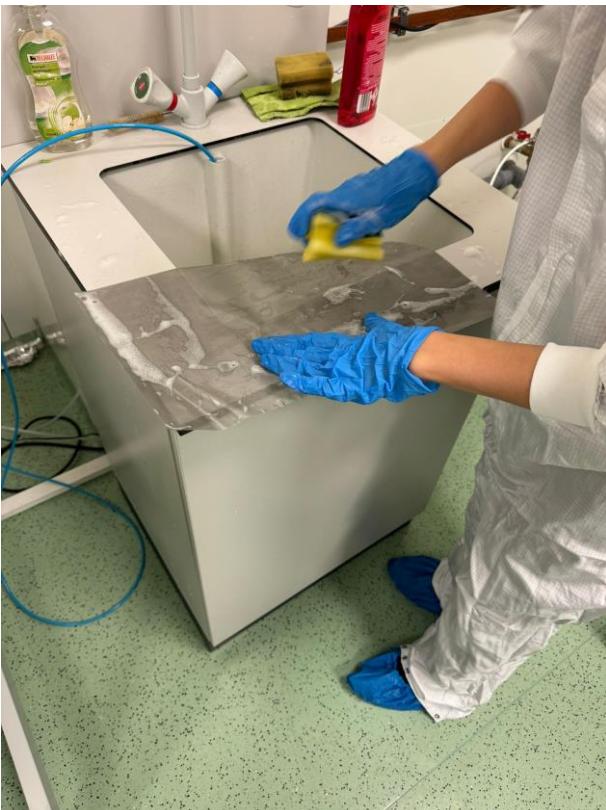
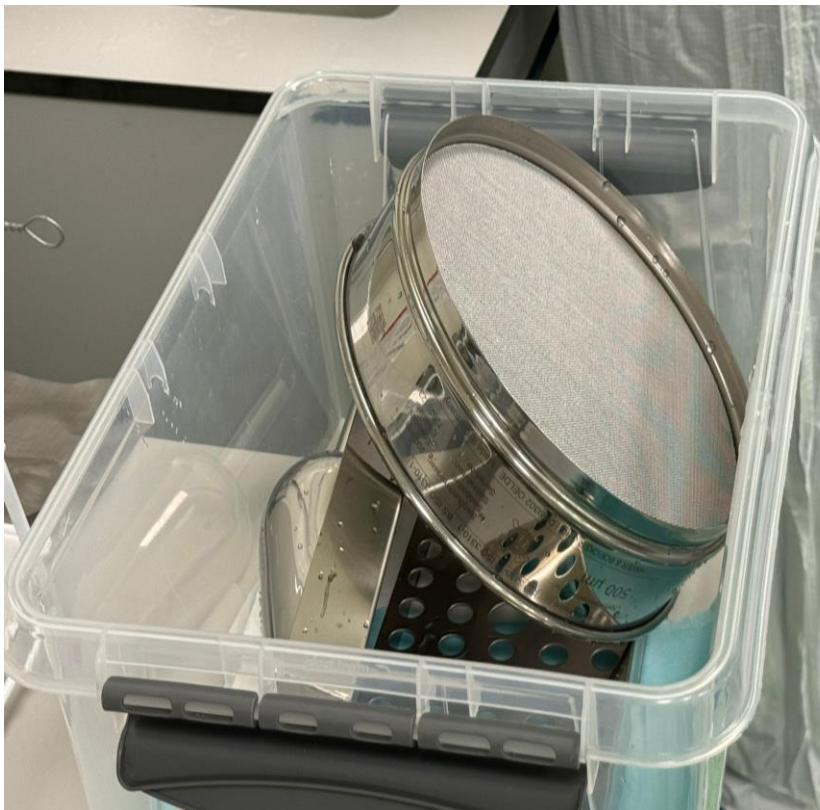
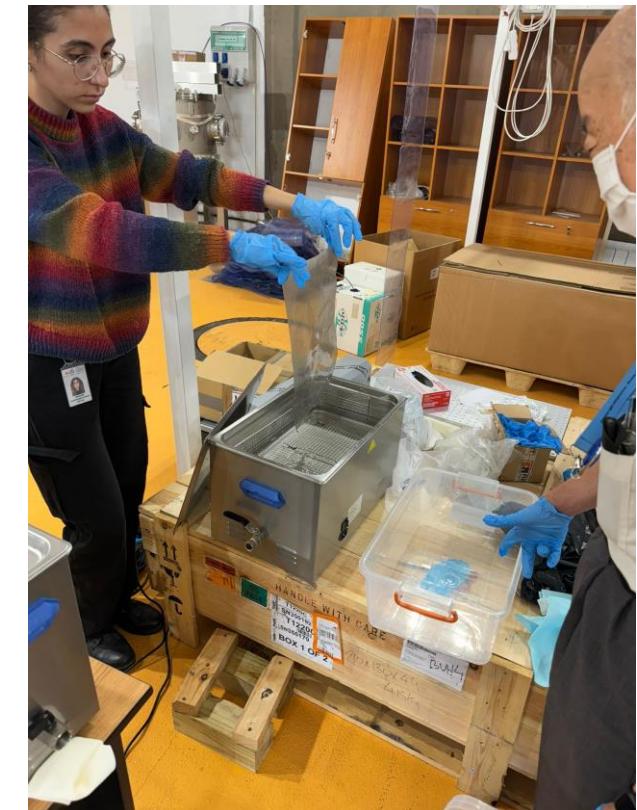
- 1) Clean up all tools that will be used in the vacuum or just simply to manipulate the silica gel (ex: metal trays, SUS mesh, sieve, scoop,etc).

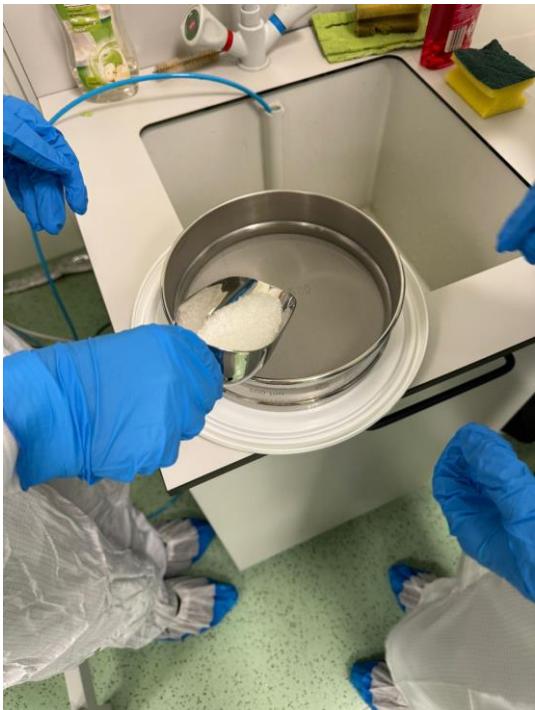
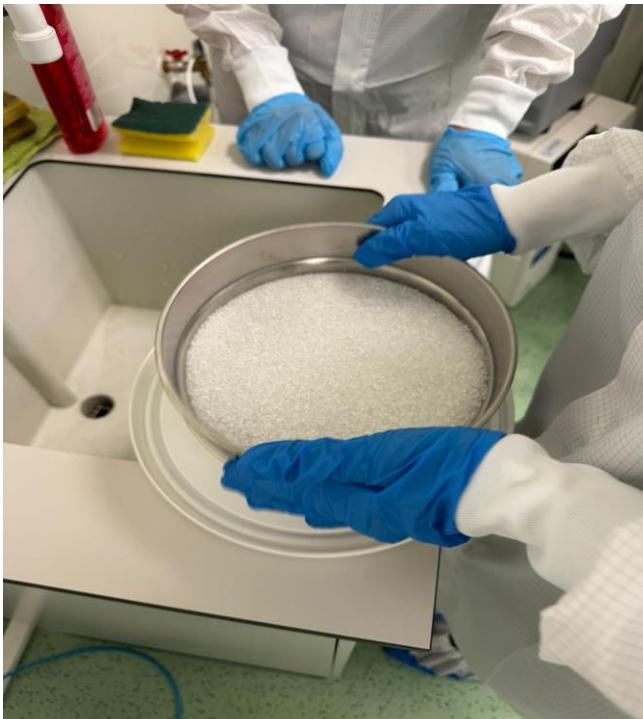
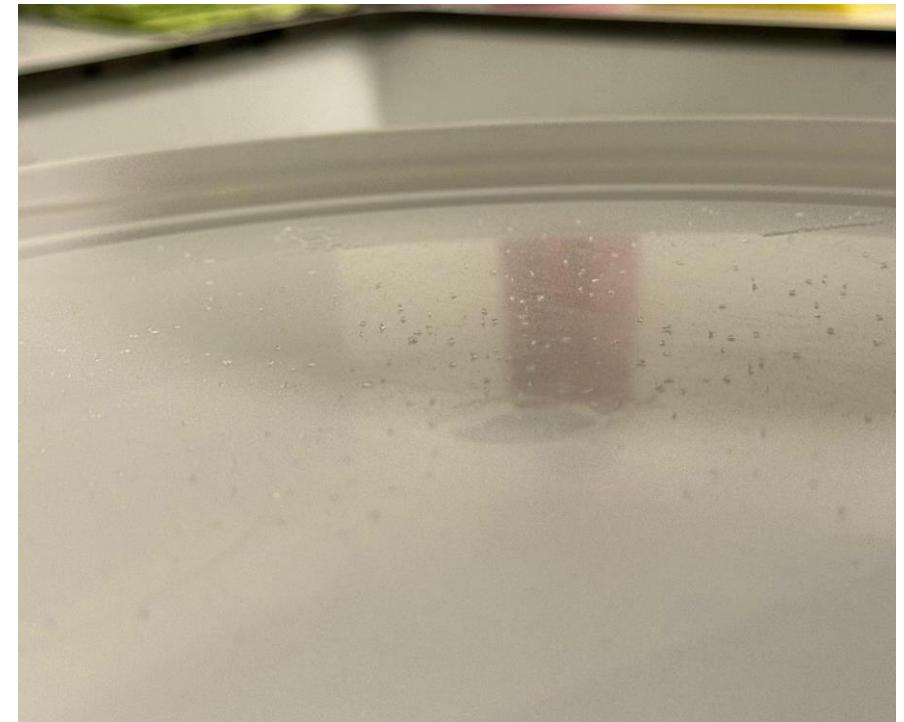
2) Sieving the silica gel to remove the small particles.

This process should be done under a ventilator.

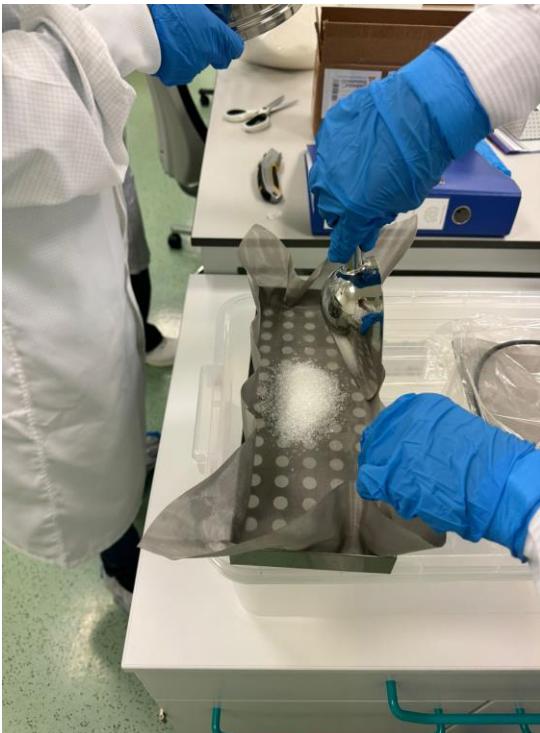
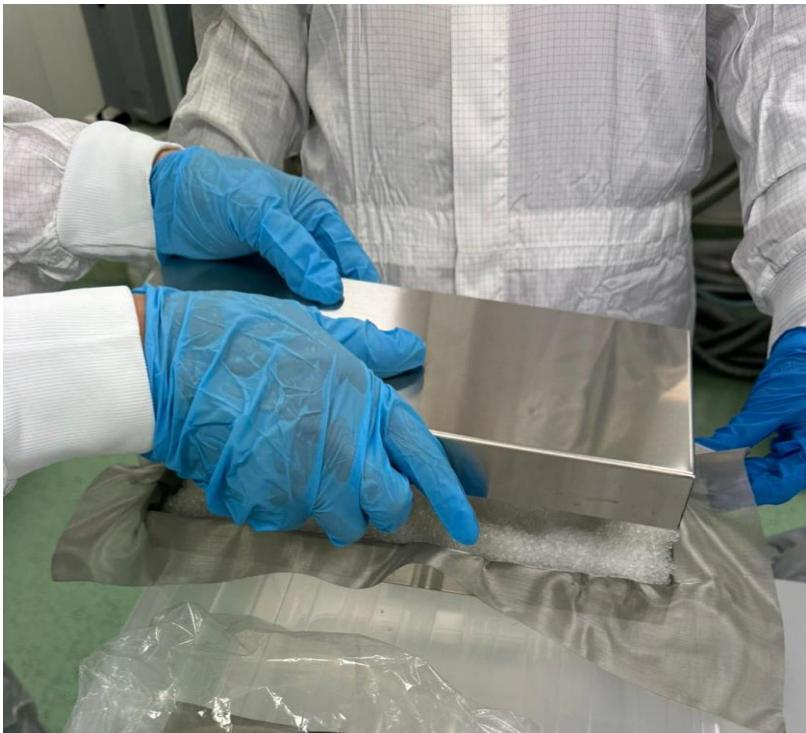
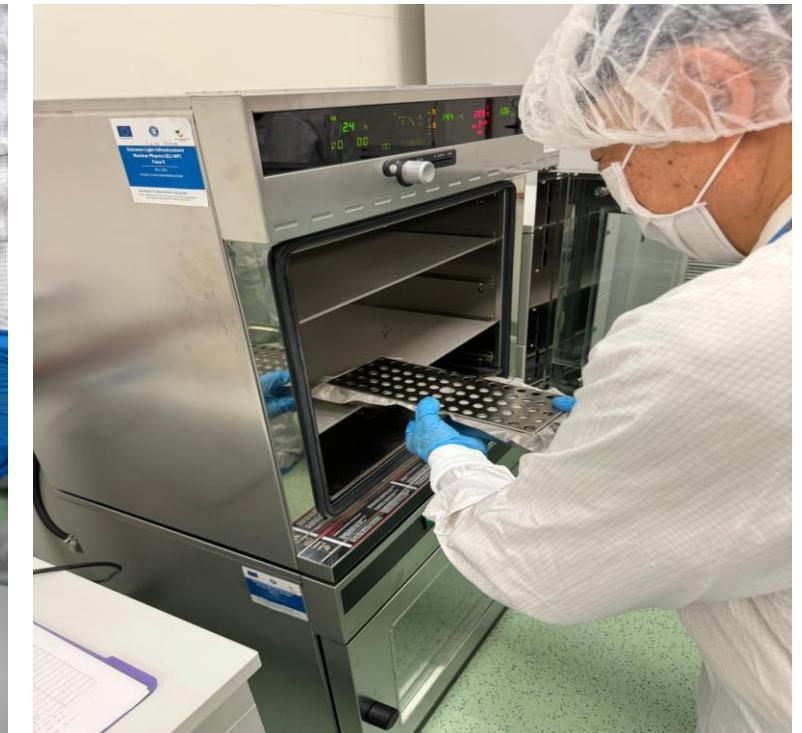
3) Baking silica gel inside the oven. at 150°C for 4 hours.

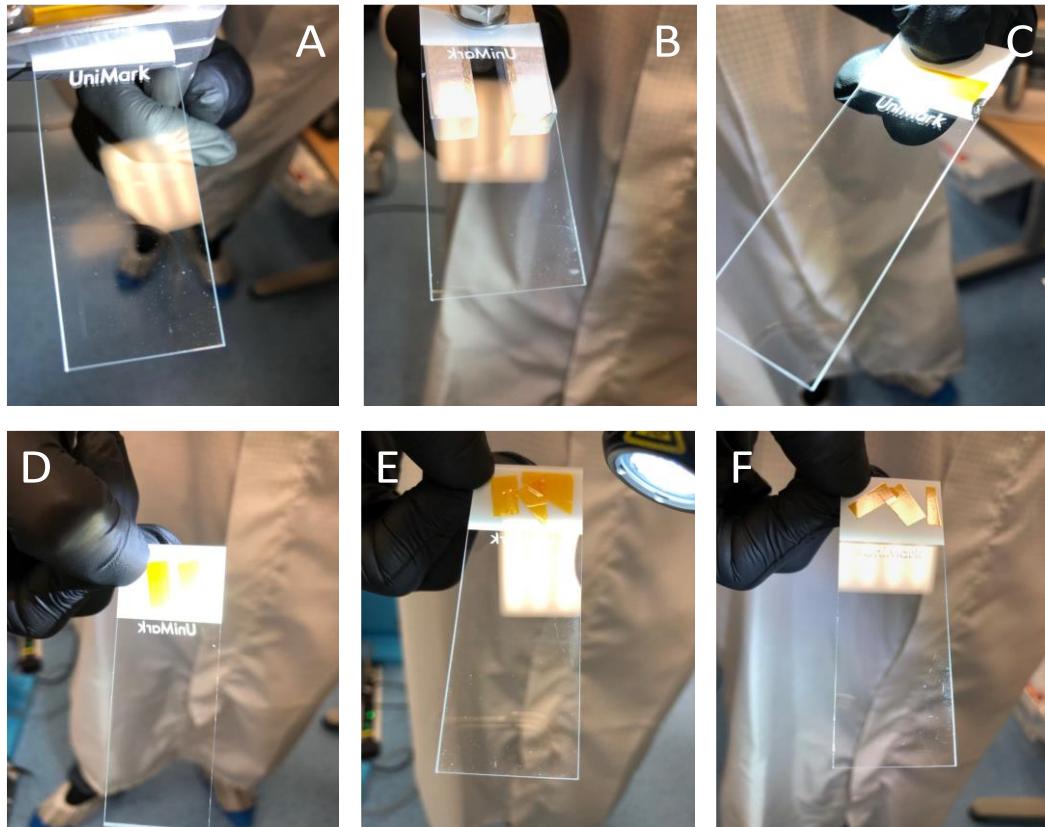
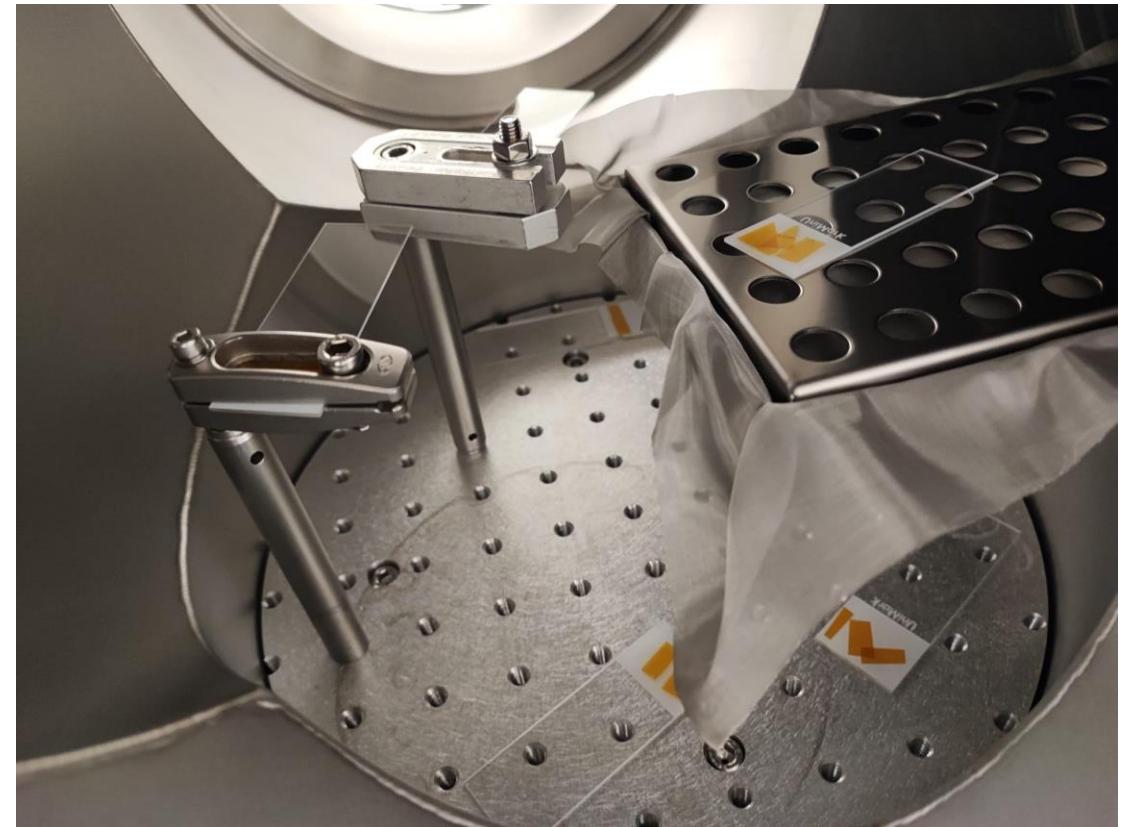
Particle contamination from silica gel was not observed.

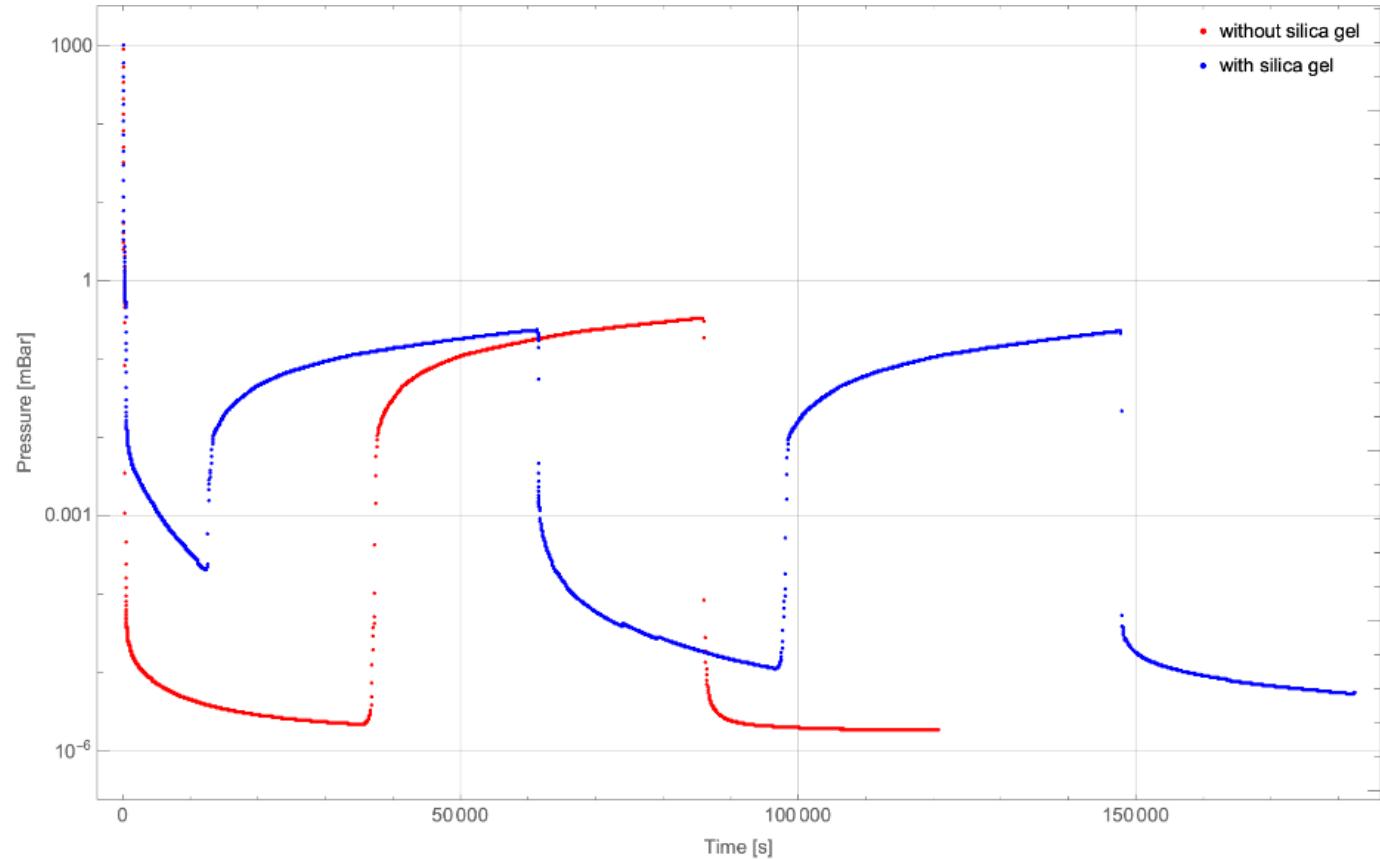
# Pump speed decrease

- Without silica gel the pressure reaches to  $3.4\text{e-}6$  mbar in 10 hours. With silica gel the final pressure is  $5.9\text{e-}6$  mbar after 20 hours. The plotted values are the average of the 60 scans.
- We need longer time to reach the final pressure, but it is not a critical issue for the system.

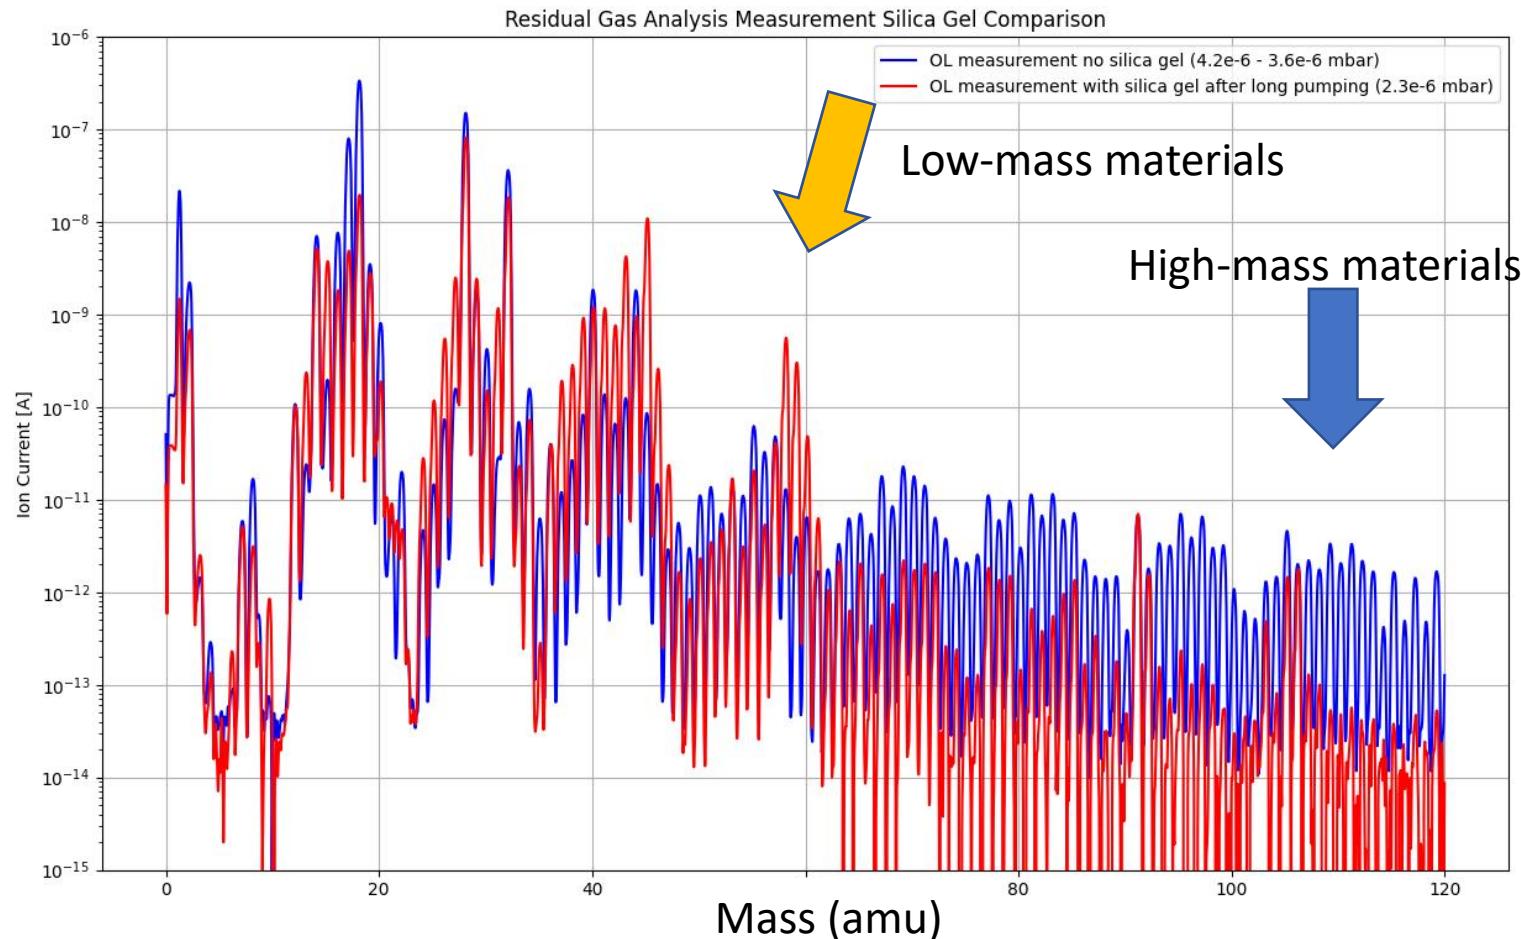
Without silica gel

With silica gel

RGA data showed that silica gel is strongly absorbing large-mass numbers molecules but it emits low-mass number materials (less than 58). These materials are supposed to be organic solvents and gases.
